Power Plant Maintenance

Traveling Water Screen Repair

Project Location: Indiantown & Cocoa, Florida

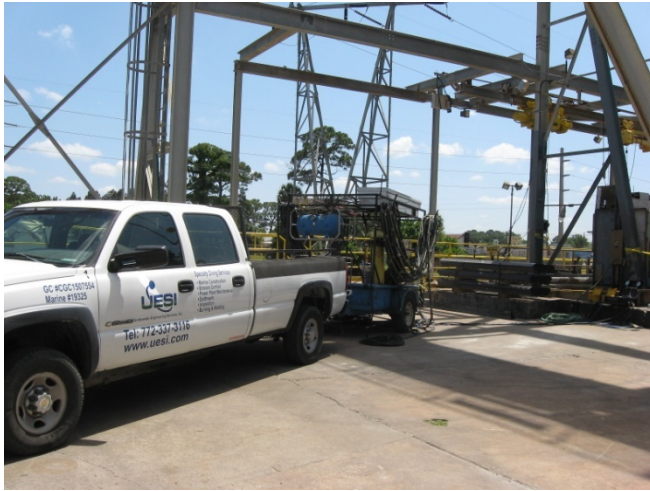
The client's power plant was reduced to limited power production due to problems with a traveling water screen. UESI put divers on site within two hours of receiving the call and performed a complete underwater video inspection. The screen had a broken carrier chain, lower unit sprocket damage, shaft damage and guide damage. The unit was removed, rebuilt and replaced.

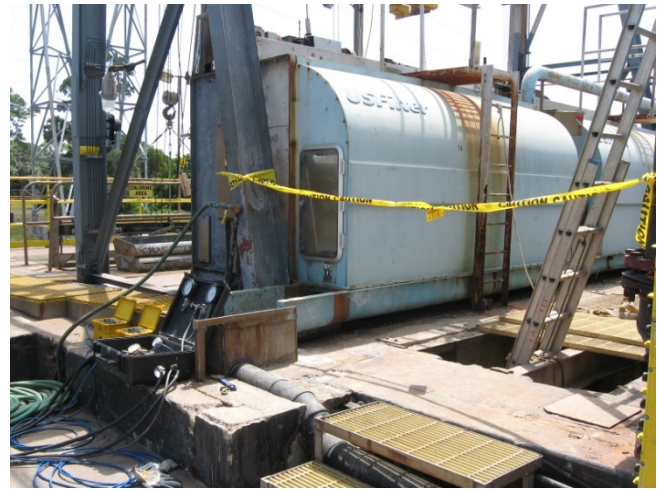
The plant required urgent attention due to a malfunctioning traveling water screen. UESI mobilized a crew and equipment and were onsite inspecting the screen within four hours of receiving the call. The unit was jammed due to a broken anode lodged in the lower unit. Divers cleared debris and turned the unit over to client
