Pile Jacket Repair

Structure Restoration – Pile Jacket Repair

Project Location: Tampa, Florida

UESI Job Number: COM2011207

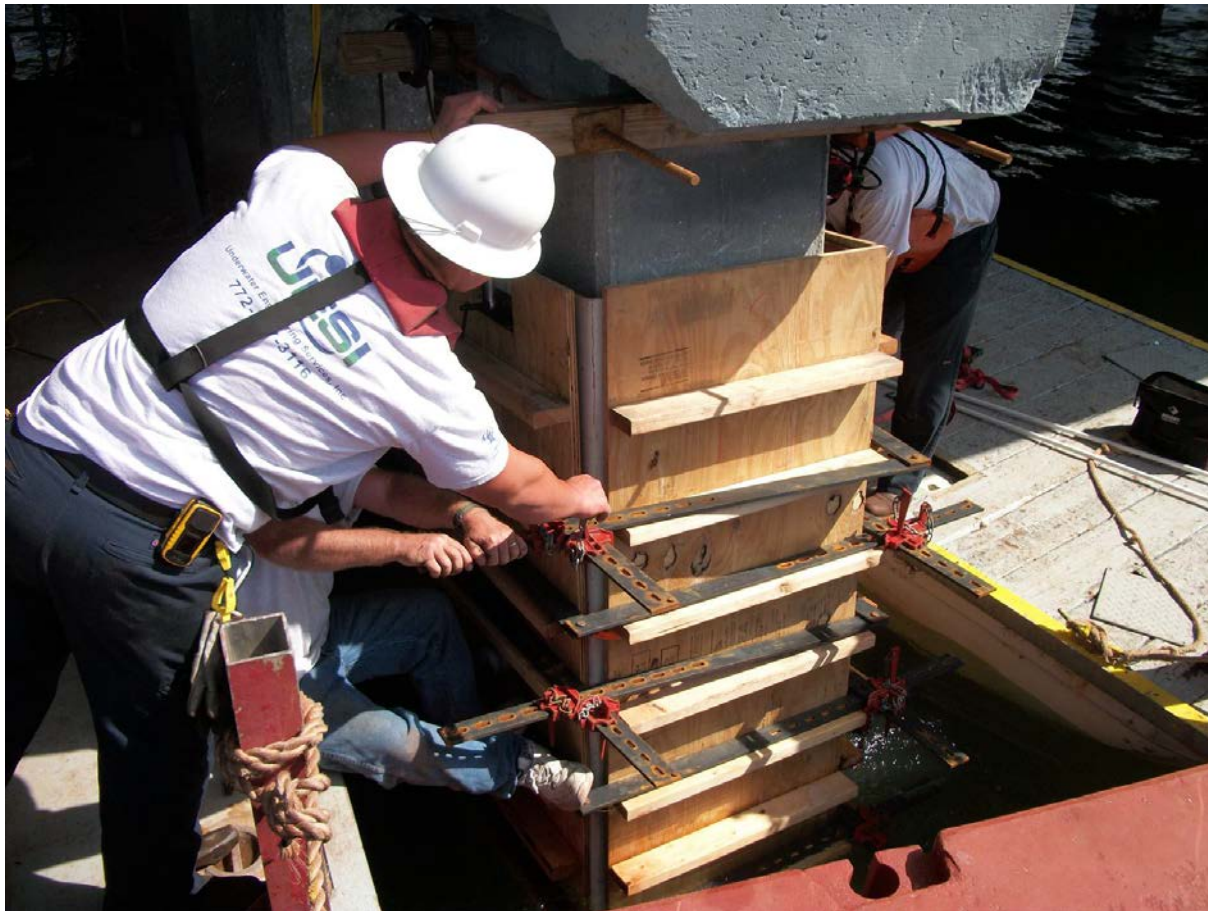
The UESI crews utilized four vessels and two configurations of sectional barges for work platforms to stage work to repair the pilings on the Howard Frankland Bridge across Tampa Bay. One hundred and thirty-one pilings were repaired using stay-in-place fiberglass jackets. The approved grout or concrete was pumped into the jacket forms from ready-mix trucks staged on the bridge deck once a week. Sixty seven of the piling repairs included a zinc cathodic protection system that UESI crews connected and had tested by a third party to ensure system functionality. One hundred and twelve of the pilings required reinforcing steel cages based on the condition of the reinforcing steel.
